Figure 5
 Boring Location Map
 Lake Wilde

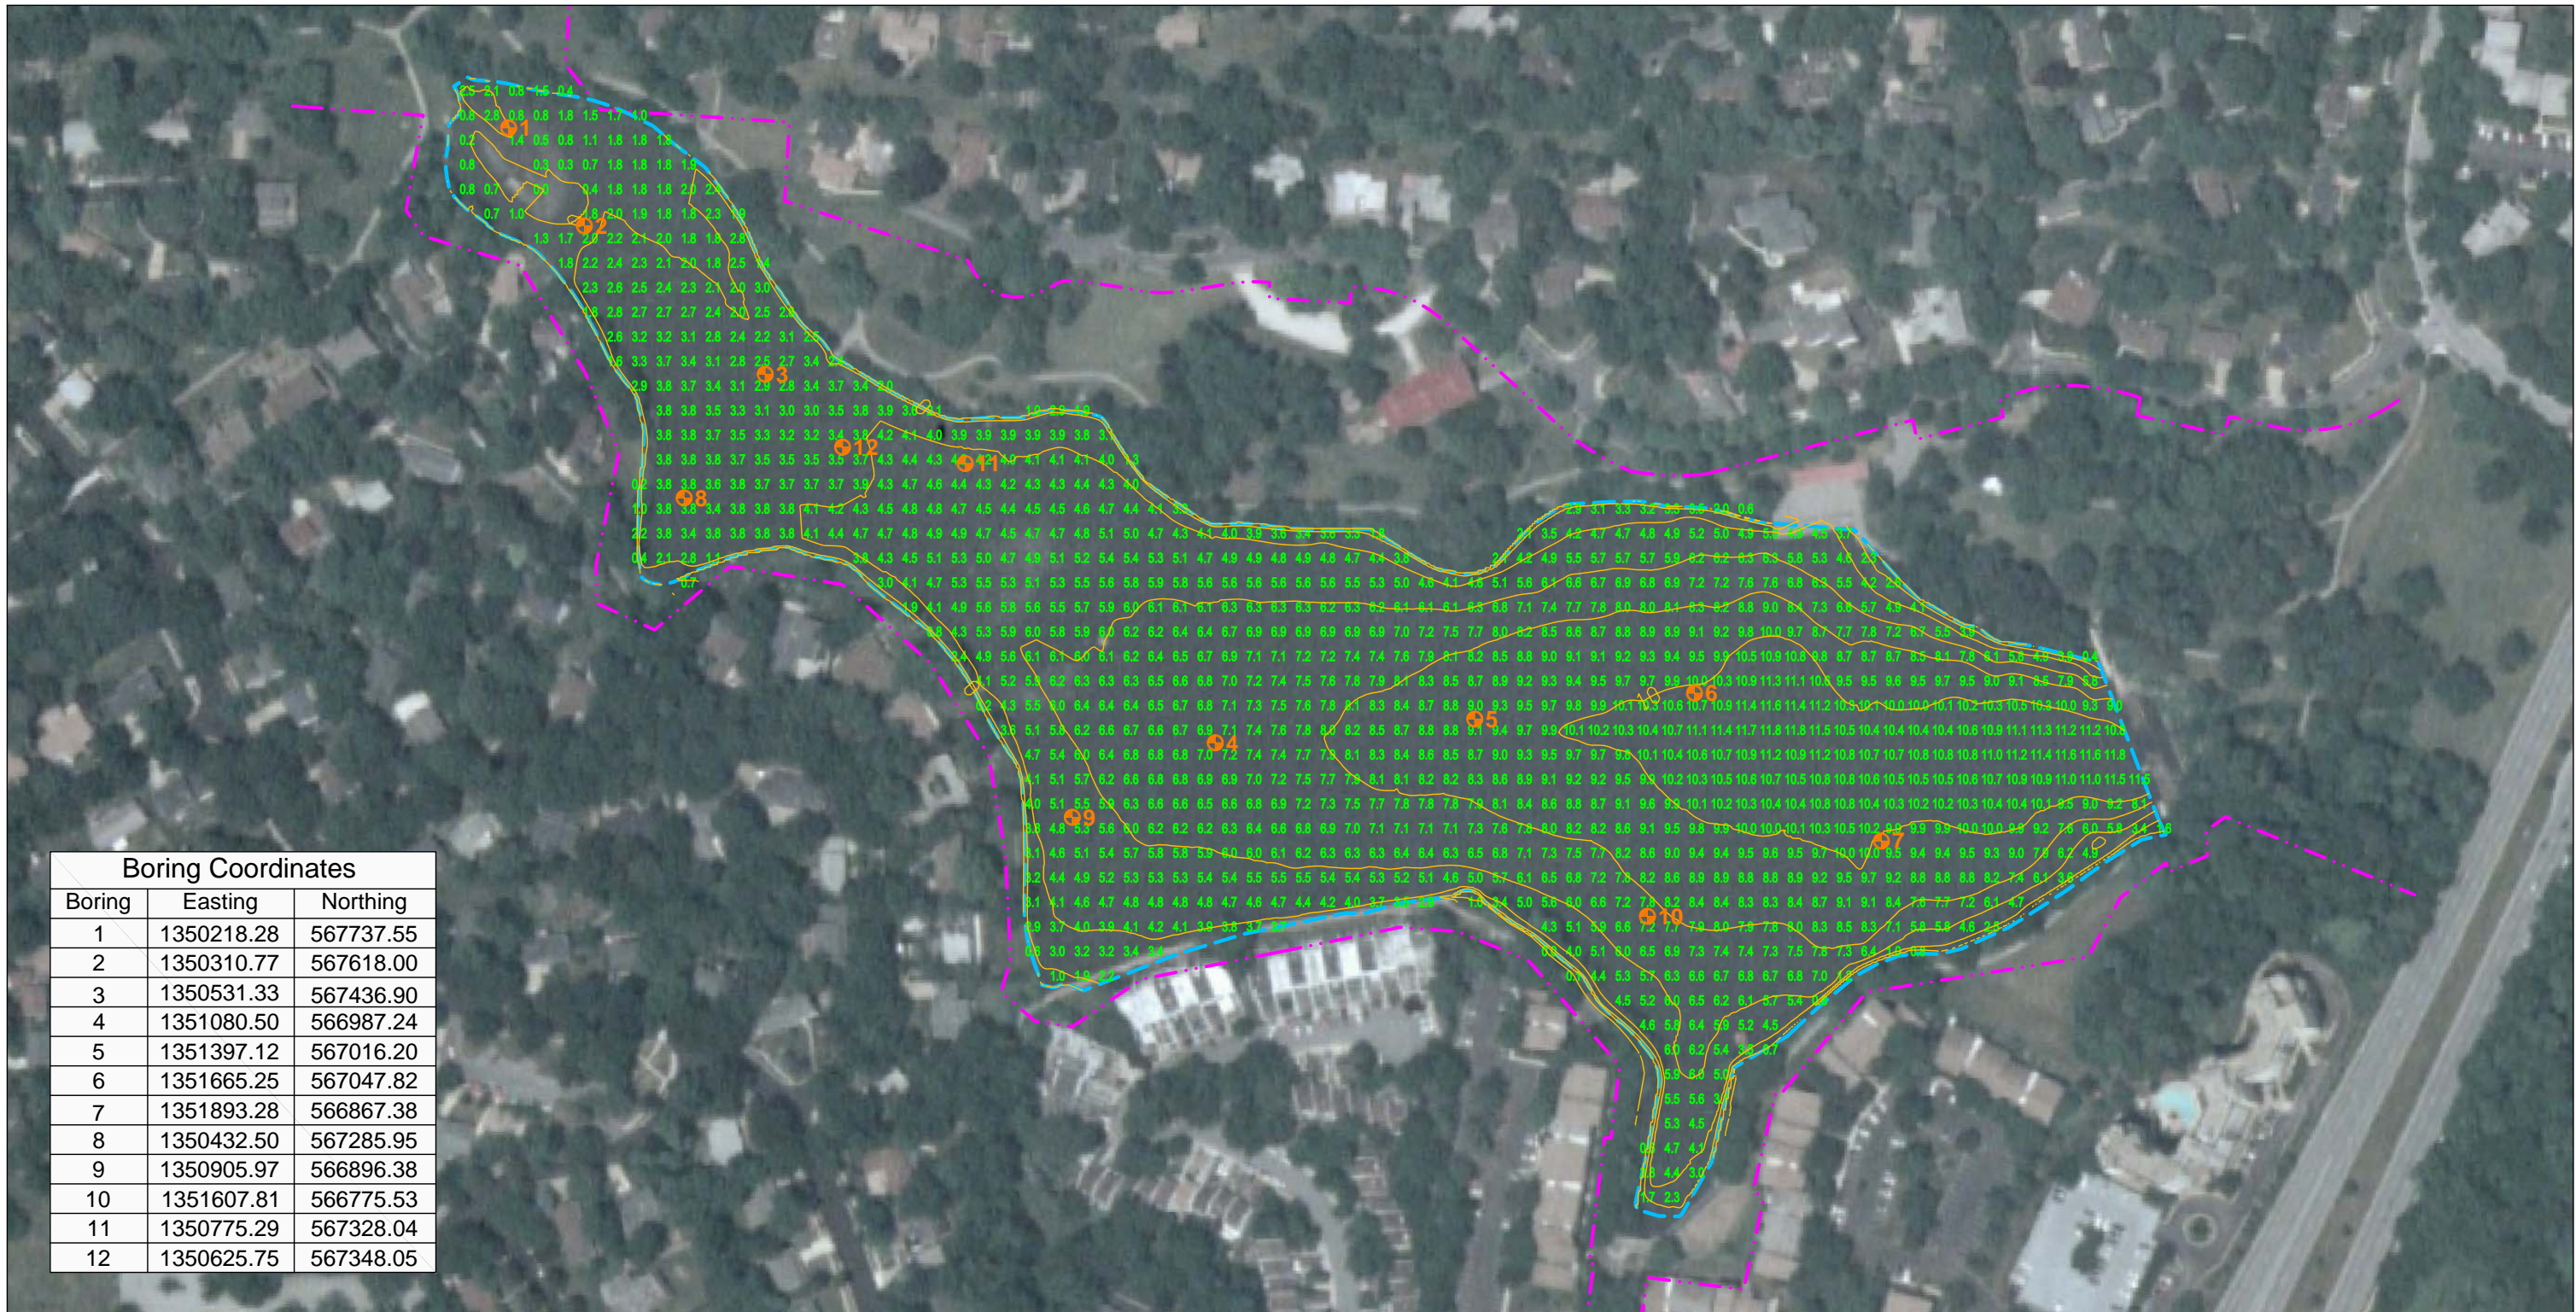
Boring Coordinates		
Boring	Easting	Northing
1	1350218.28	567737.55
2	1350310.77	567618.00
3	1350531.33	567436.90
4	1351080.50	566987.24
5	1351397.12	567016.20
6	1351665.25	567047.82
7	1351893.28	566867.38
8	1350432.50	567285.95
9	1350905.97	566896.38
10	1351607.81	566775.53
11	1350775.29	567328.04
12	1350625.75	567348.05

Source: Aerial from USGS, 2006.
 Horizontal Datum: Maryland State Plane, NAD 83, U.S. Survey Feet.
 Vertical Datum: NAVD88.

Note: Existing conditions drawing is compiled from field data performed 6/24/03, interpolated by AutoCAD 2000 by Environmental Quality Resources, L.L.C., and hand corrected for graphical representation.
